Portage Creek Sediment Remediation Project Kalamazoo, Michigan

Pre-Sediment Removal Structure Feature Assessment
Removal Areas SA1-A, SA1-B and SA1-C

F&V Project Number: 809930
May, 2013

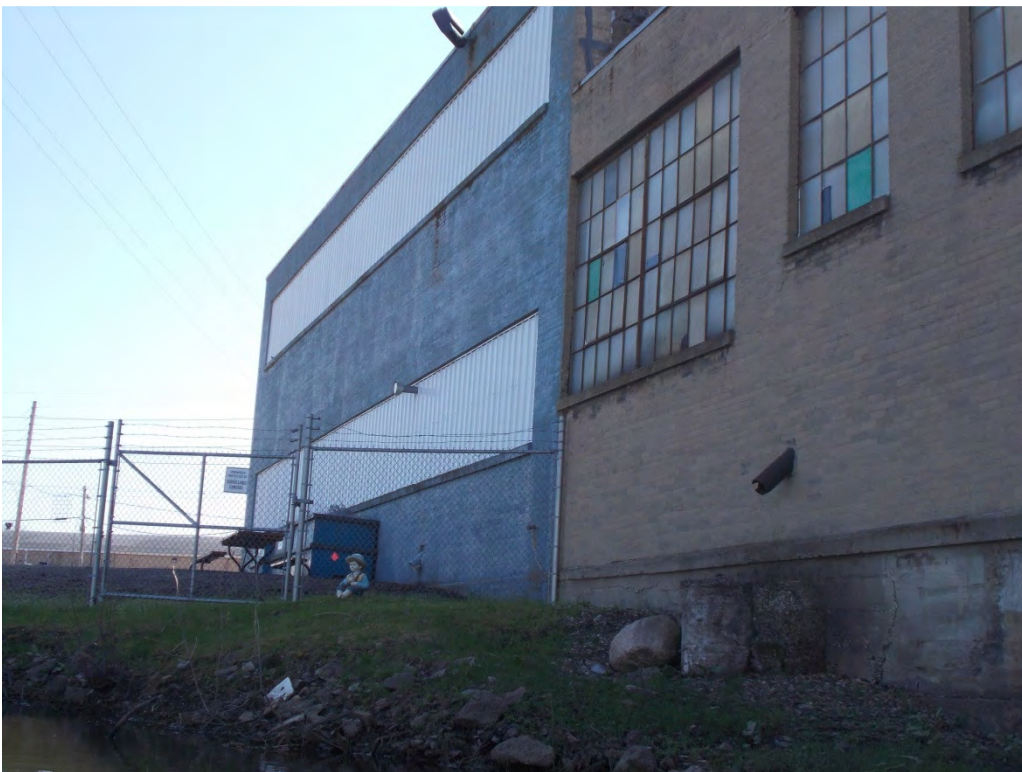
View of structure looking east

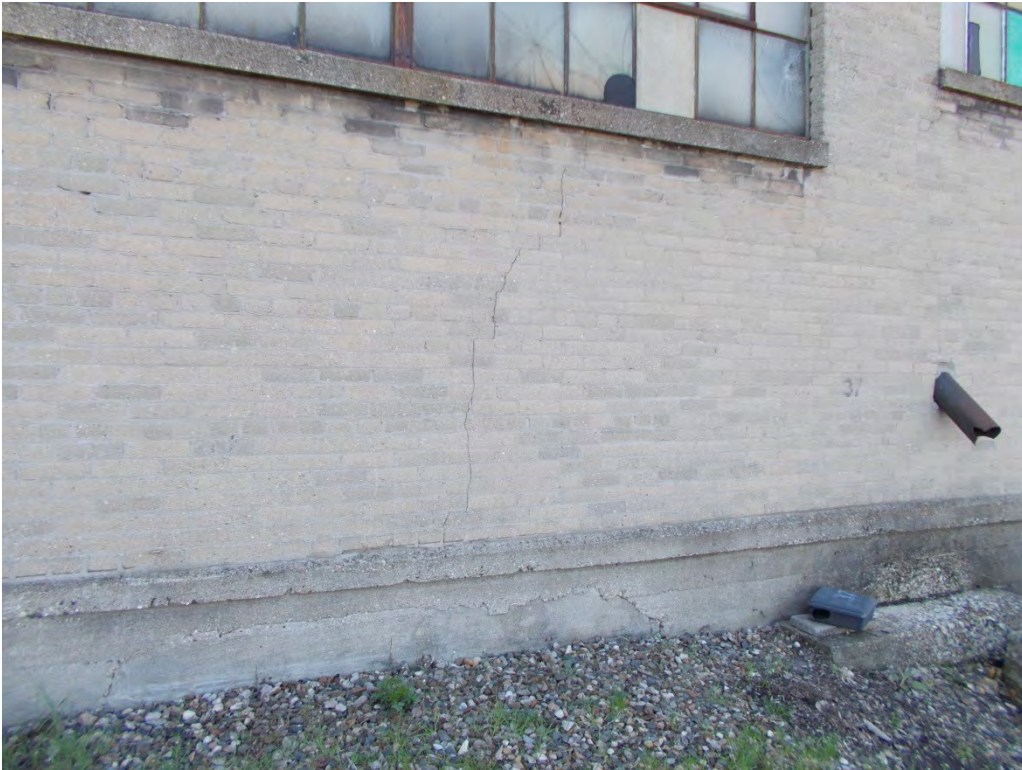
- Minor cracking, severe honeycombing and exposed form ties were noted in the concrete foundation wall.
- The footing is exposed upstream of SA1-C. Minor undermining was noted at the building transition.
- Moderate vertical and step cracking were noted in the brick. Cracking was noted in the primary wall and originating at window penetrations.
- A minor horizontal crack was noted between the concrete foundation and brick near the building transition.
- The eastern section of the building has sealed diagonal/step cracking near the fence line.
- Consumers Energy mapping shows a 2" gas crossing Portage Creek, however it appears to be west of SA1-C-S01 and outside the cofferdam limits.
- City of Kalamazoo mapping shows a water main crossing Portage Creek, however it appears to be west of SA1-C-S01 and outside the cofferdam limits.

Step cracking in brick wall

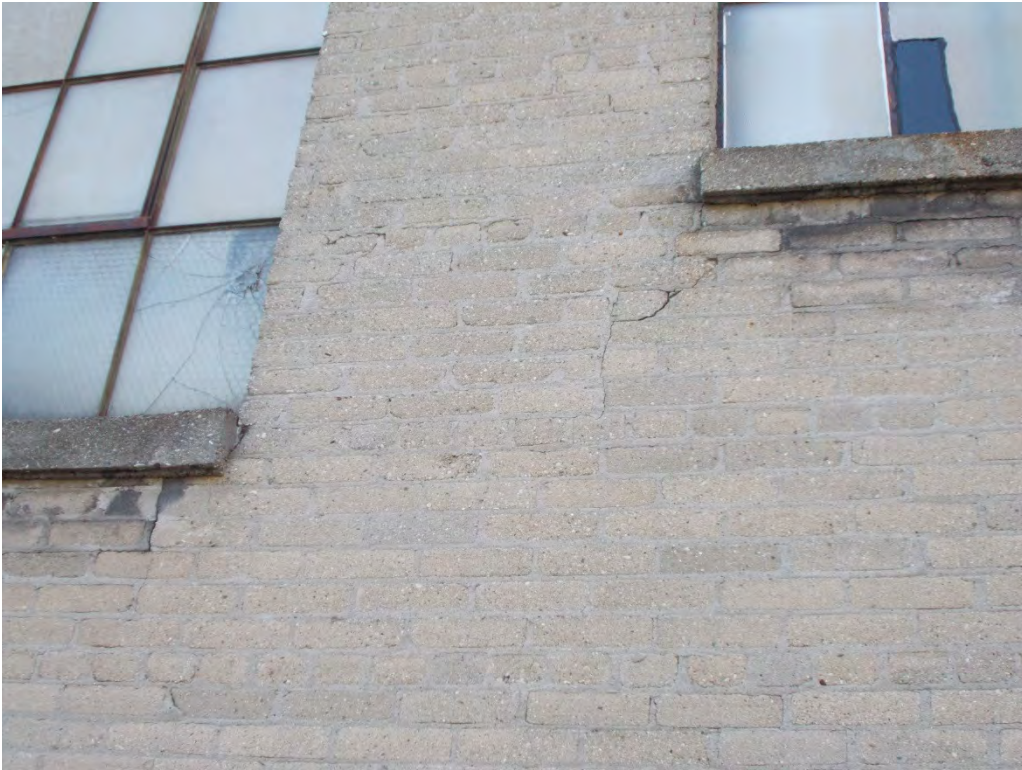
Cracking at window penetration

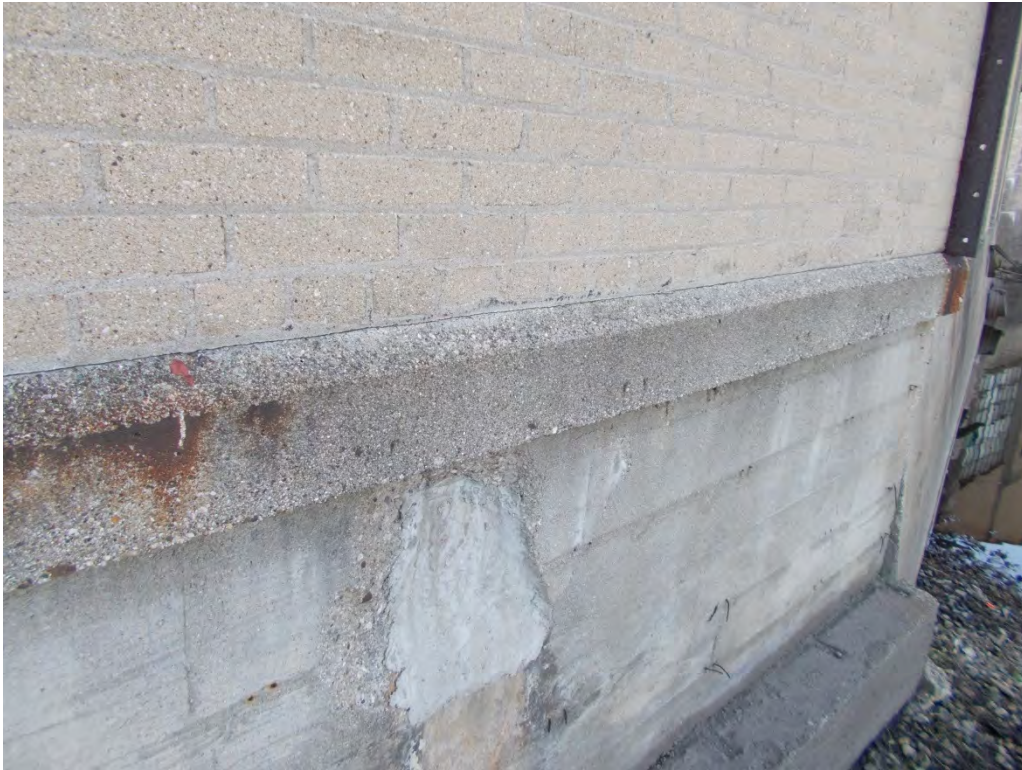
Cracking between foundation and brick

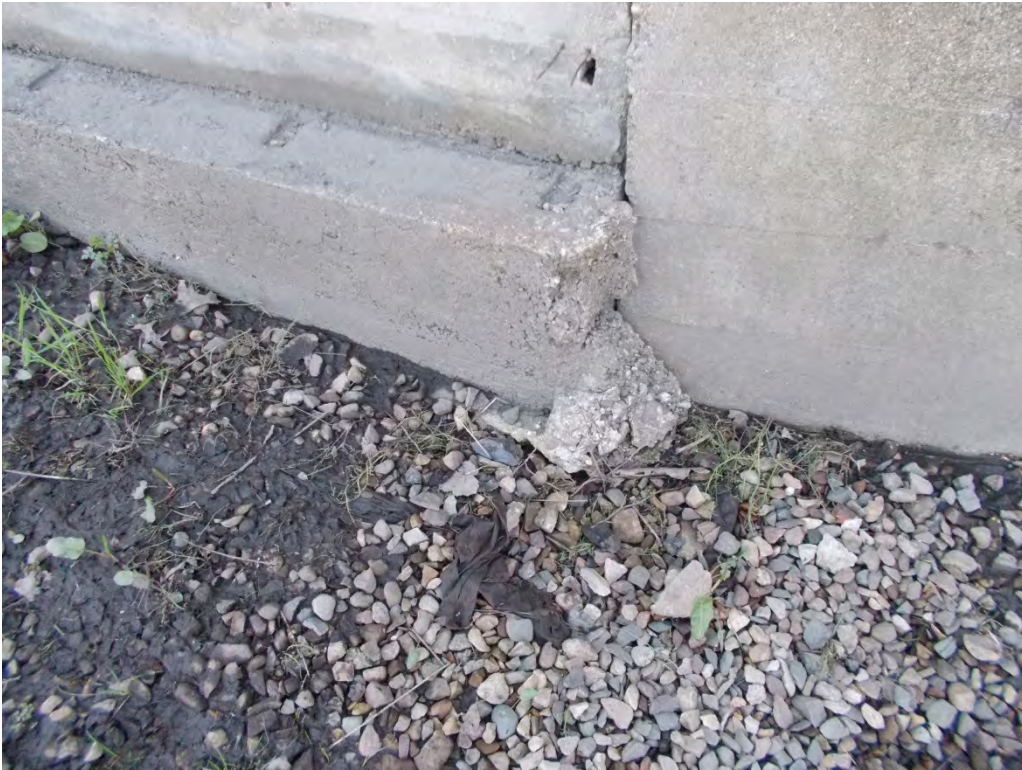
Footing undermining at building transition

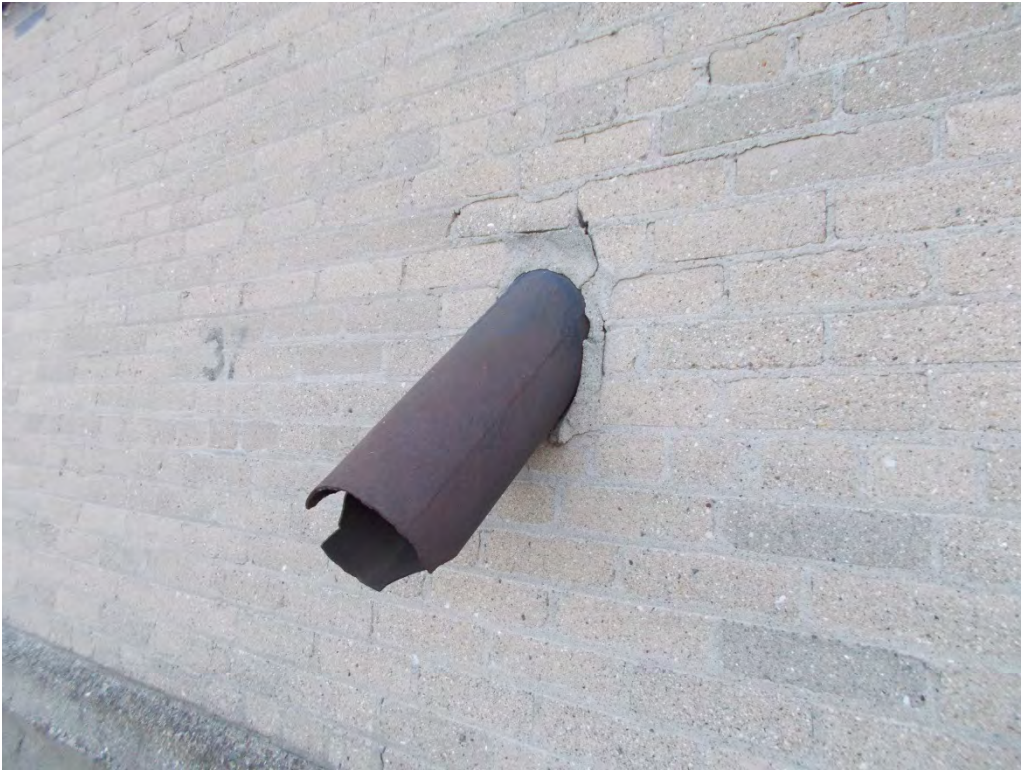
Cracking around pipe penetration in brick wall

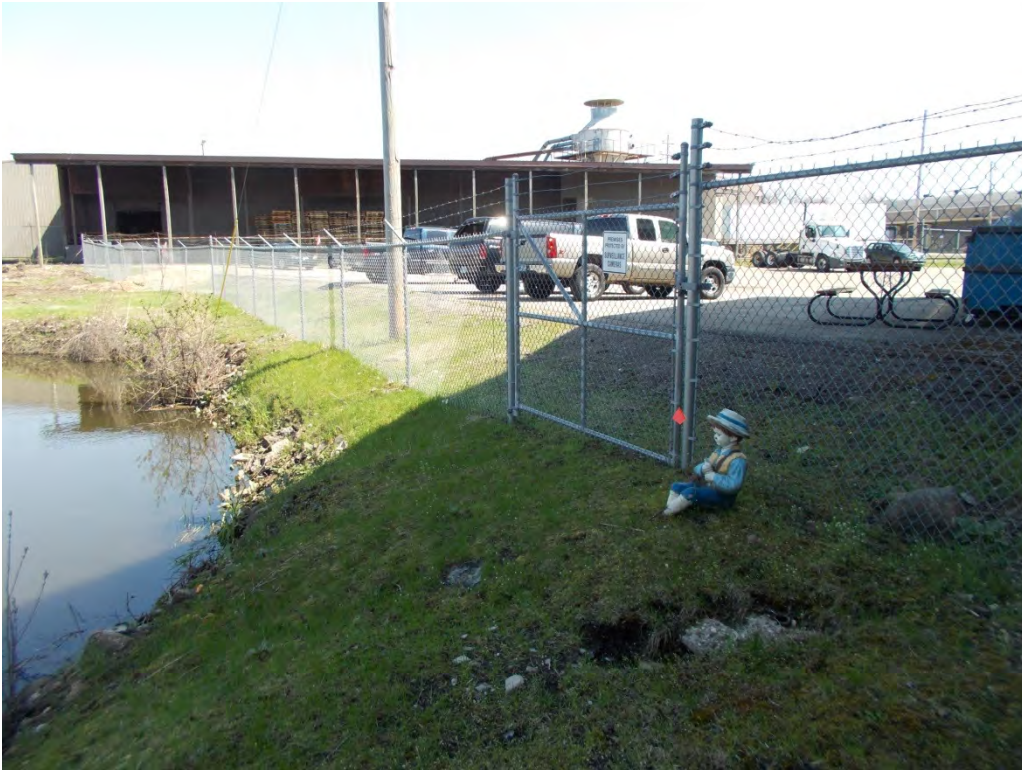
- The fence is generally in good condition, however, the barb wire has failed at the north end.

View of fence looking north

- If the fencing conflicts with sediment removal operations, it should be removed and replaced in kind.

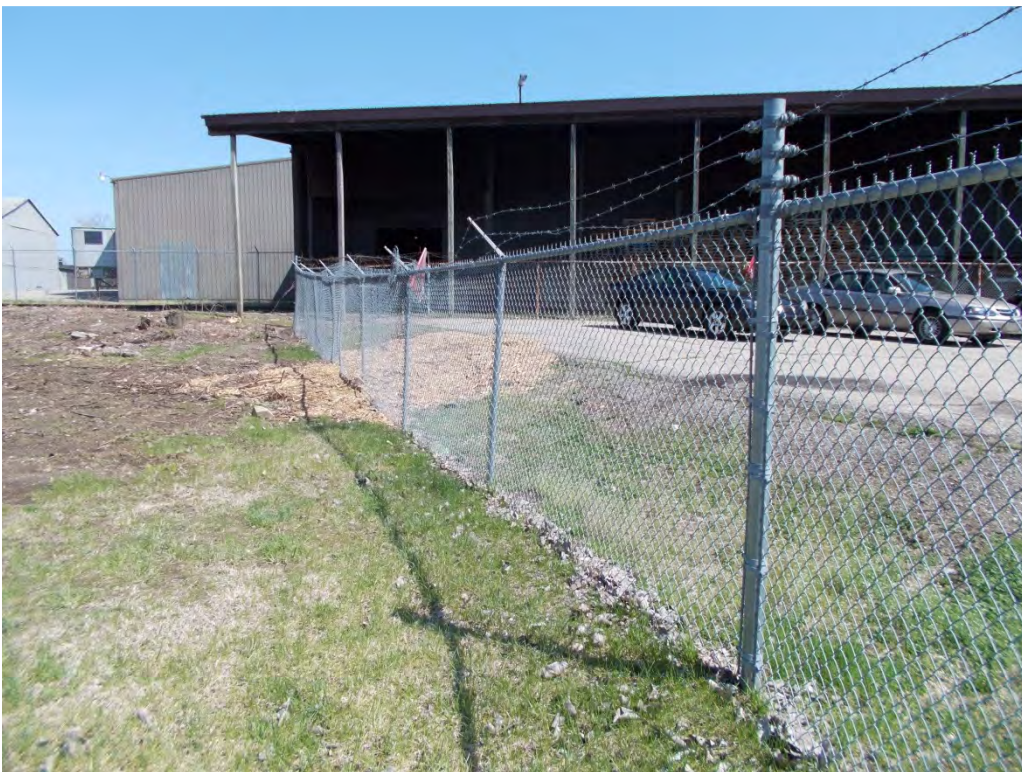
View of fence looking north

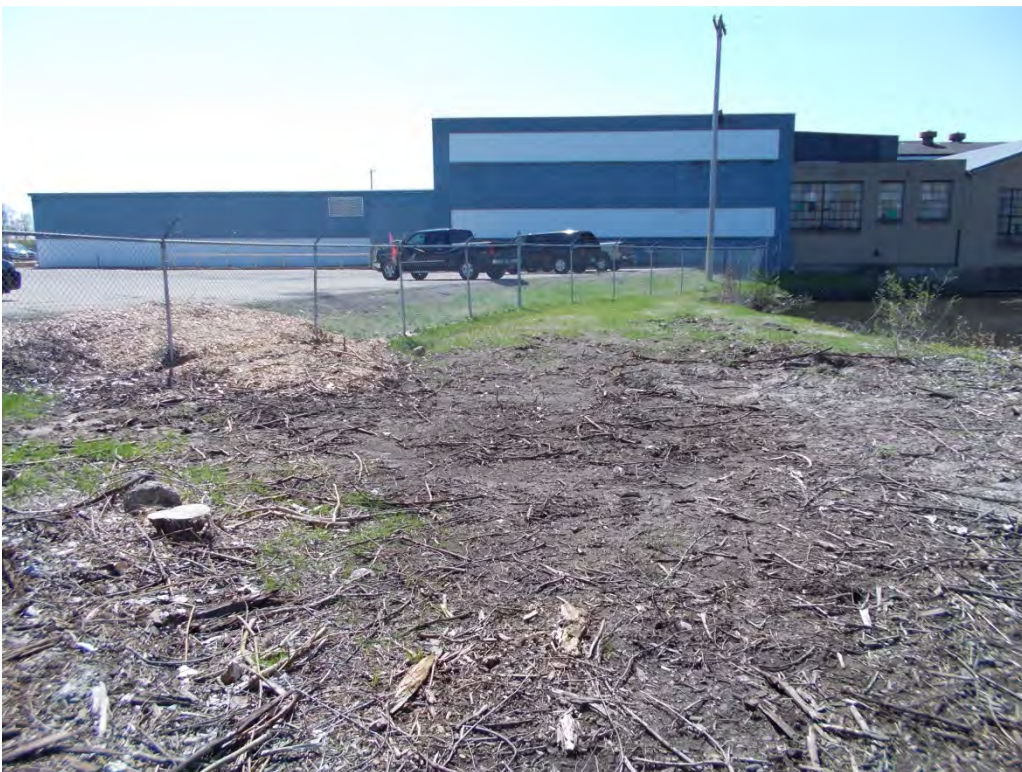
View of fence looking south

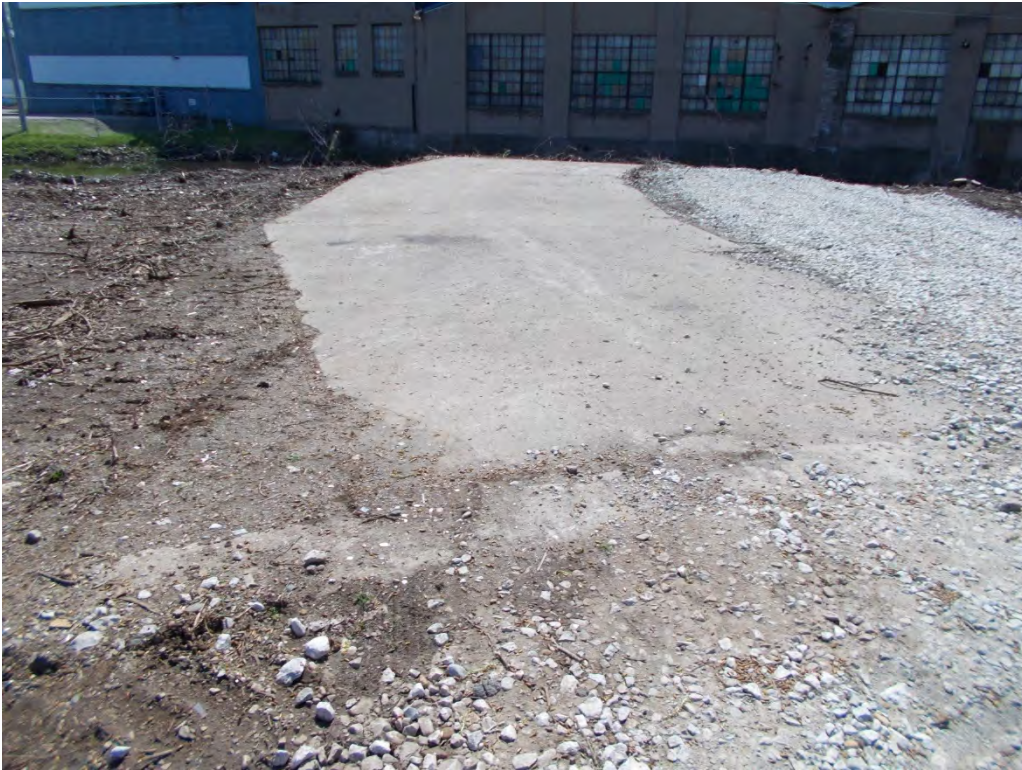
- The pavement appears to be abandoned. It is in fair condition with scattered minor to moderate cracking.
- The top of bank is eroded along the channel side of the pavement.
- There is a 2-3" void in the interior area of the pavement.
- A stone access road has been constructed around the pavement.

View of pavement looking south

- The pavement appears to be abandoned. Any damage done during sediment removal operations does not likely need to be addressed.

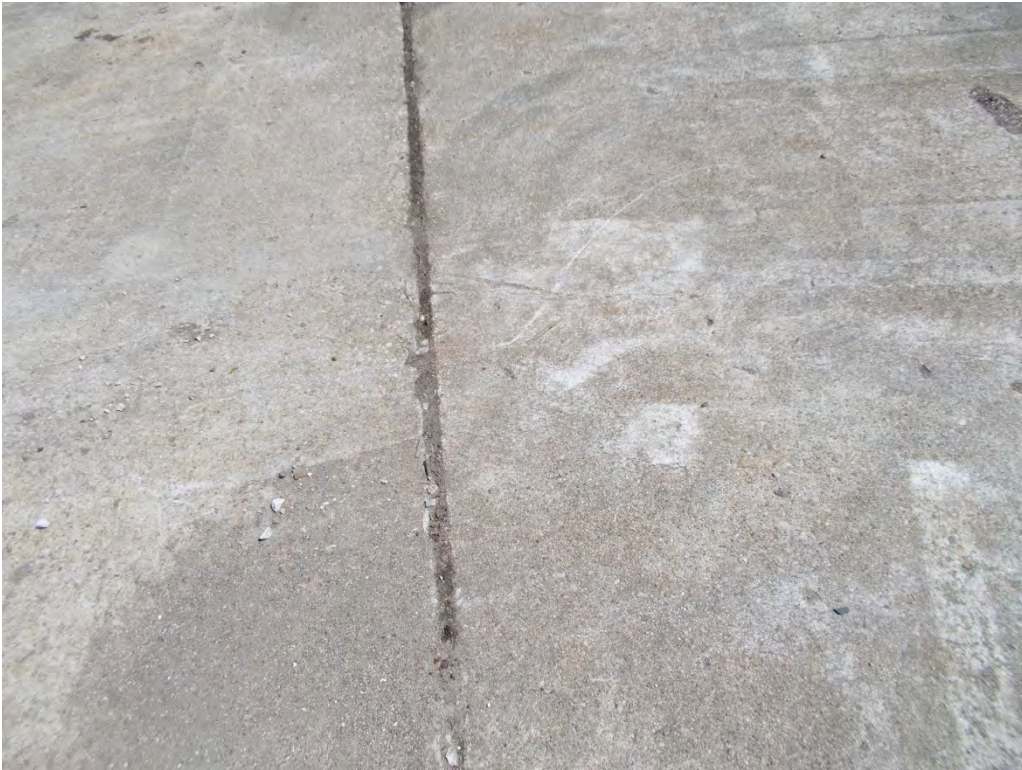
Cracking in surface of pavement

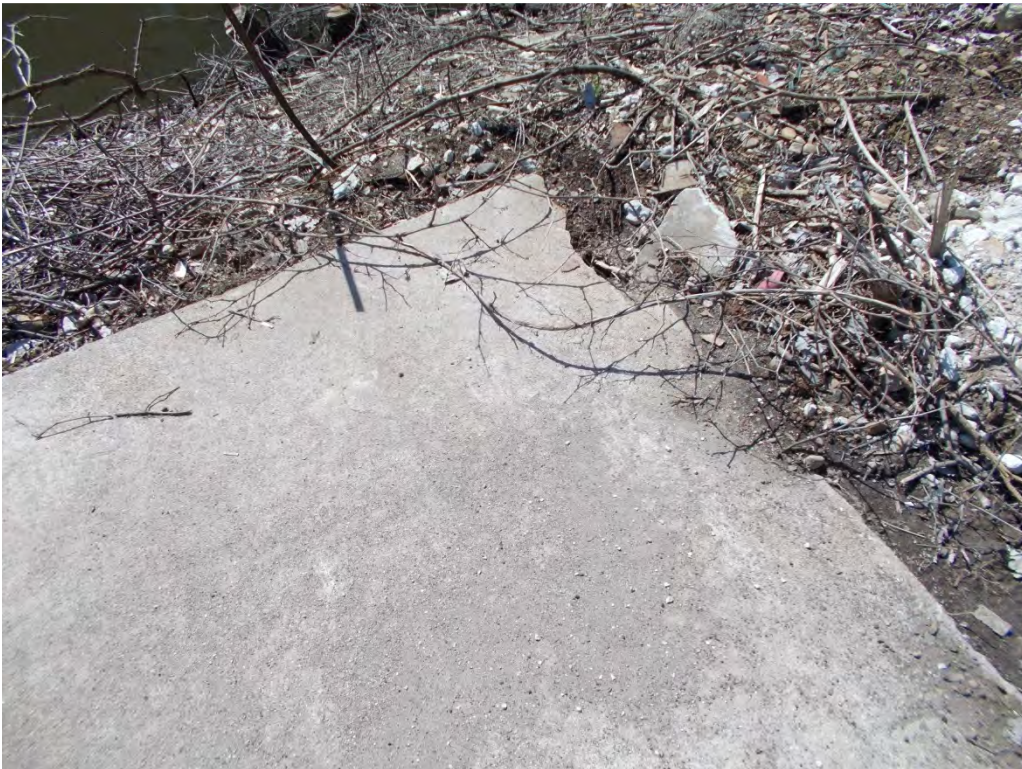
Minor spalling on corner of pavement

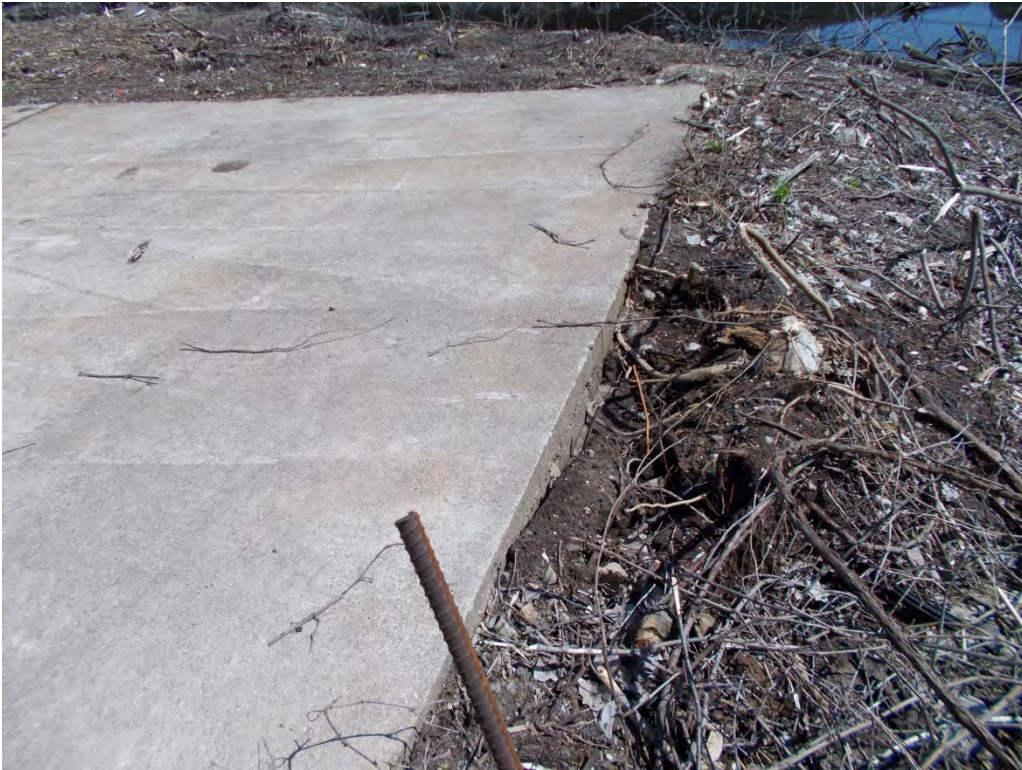
Erosion of top of bank along pavement

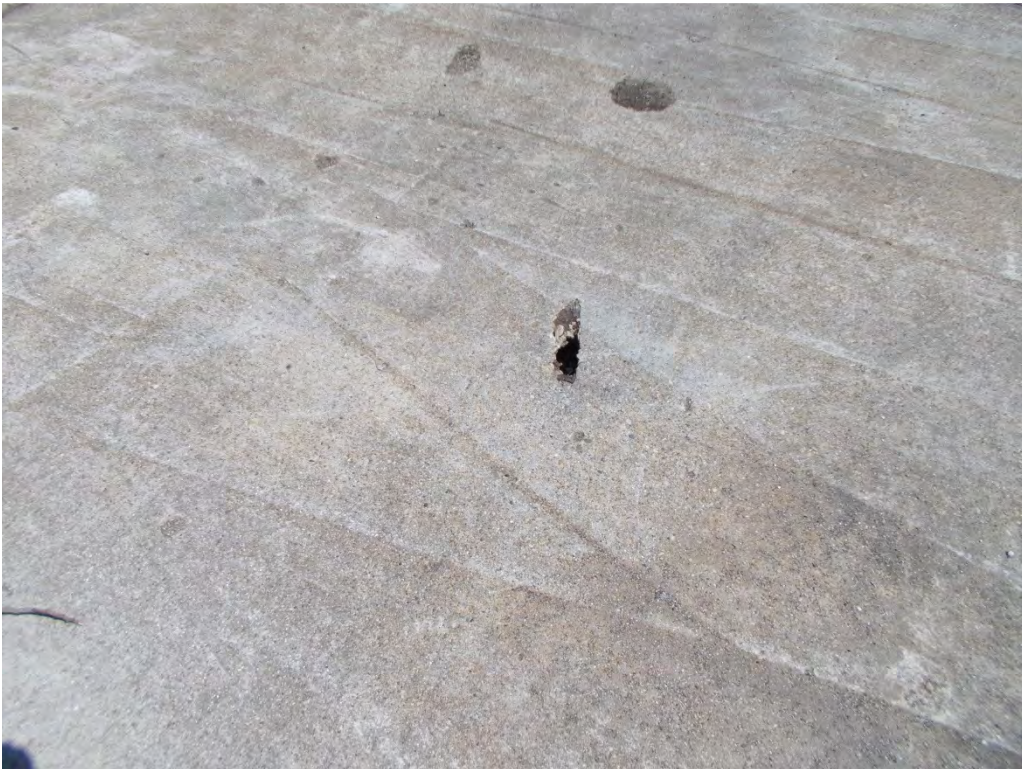
Void on interior area of pavement

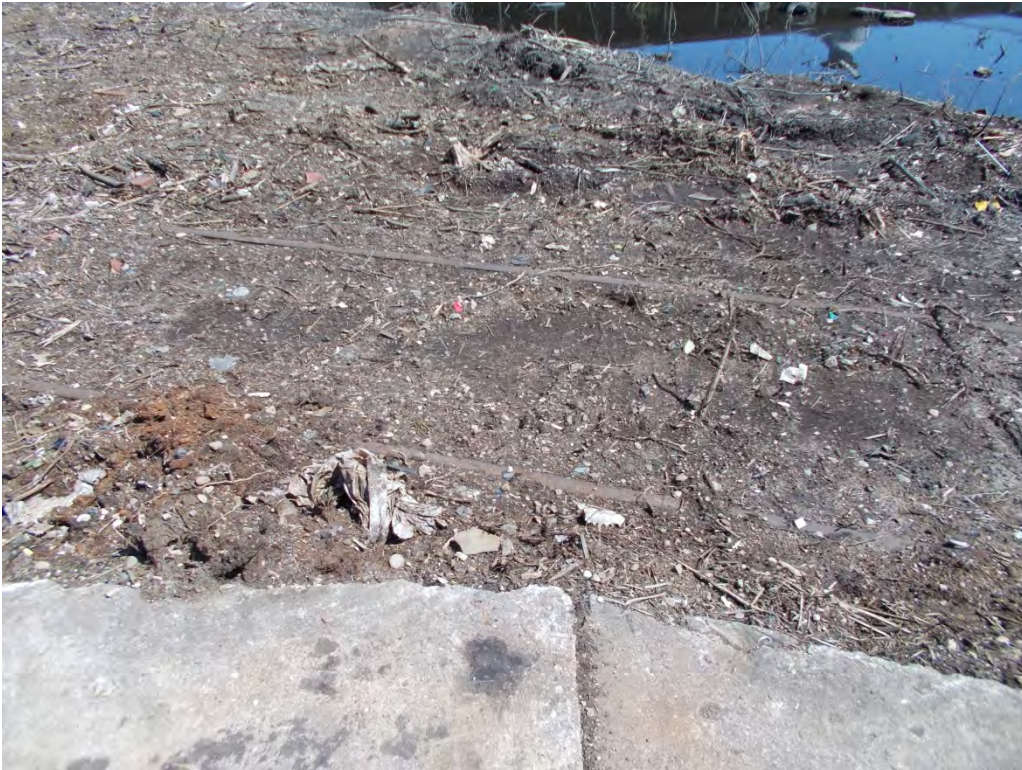
- The track appears to be in fair condition, however, the rails are almost completely covered with soil and debris.

View of track from adjacent pavement

- The track appears to be abandoned. Any damage done during sediment removal operations does not likely need to be addressed.

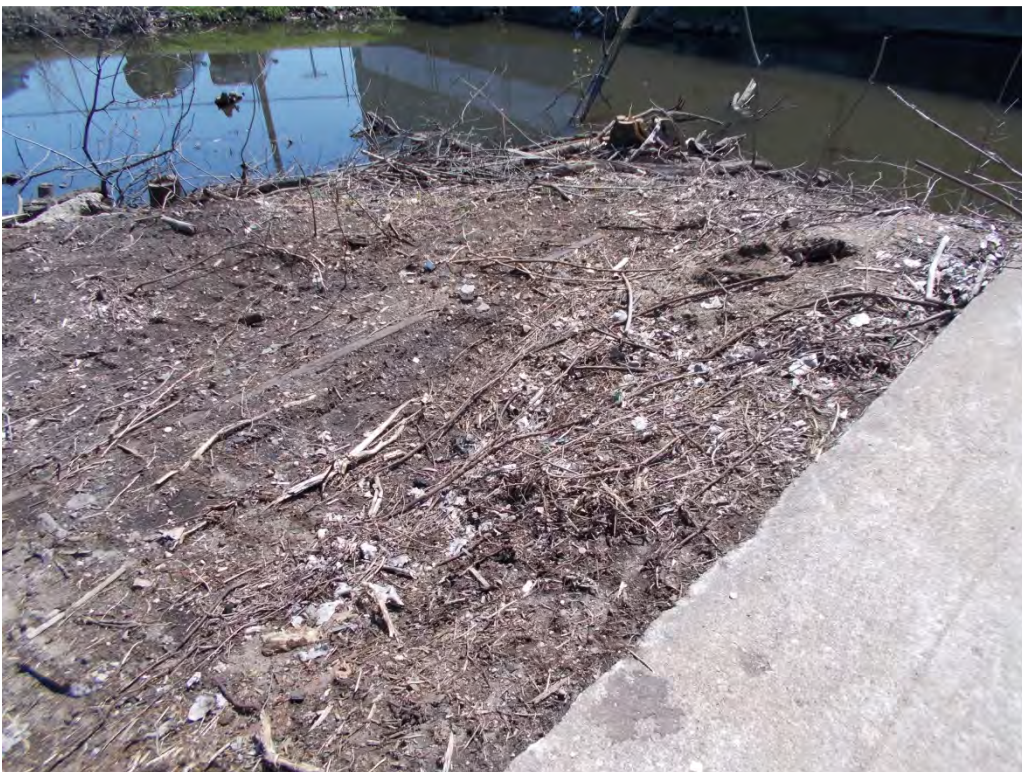
View of track looking southeast

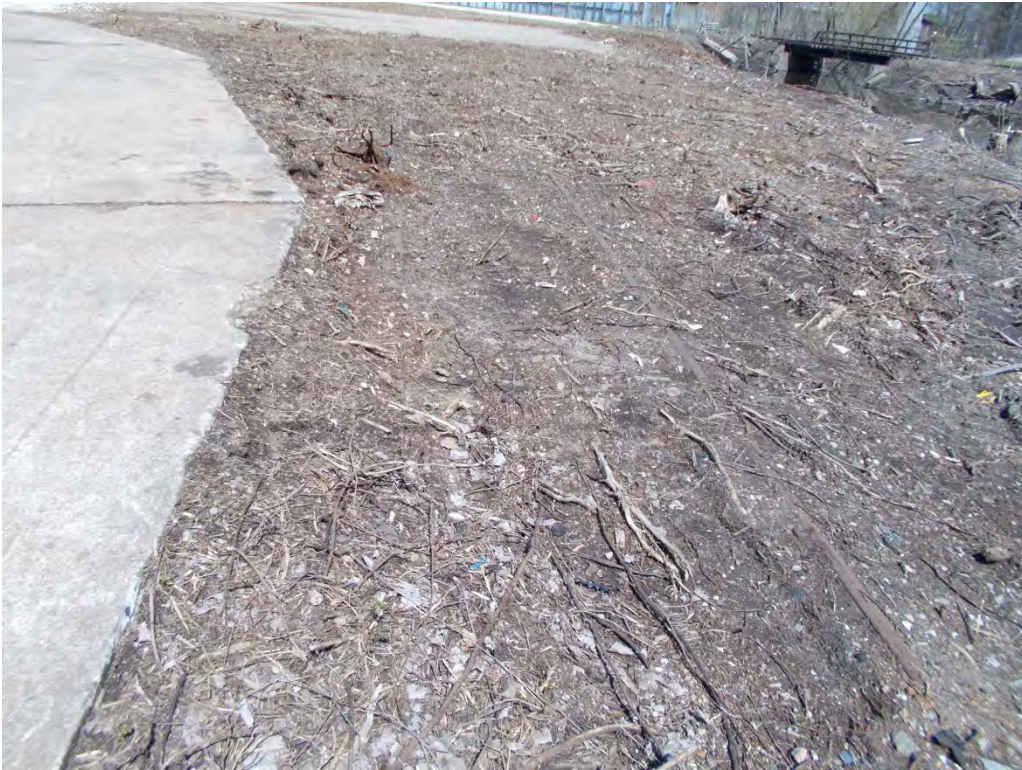
View of track looking north

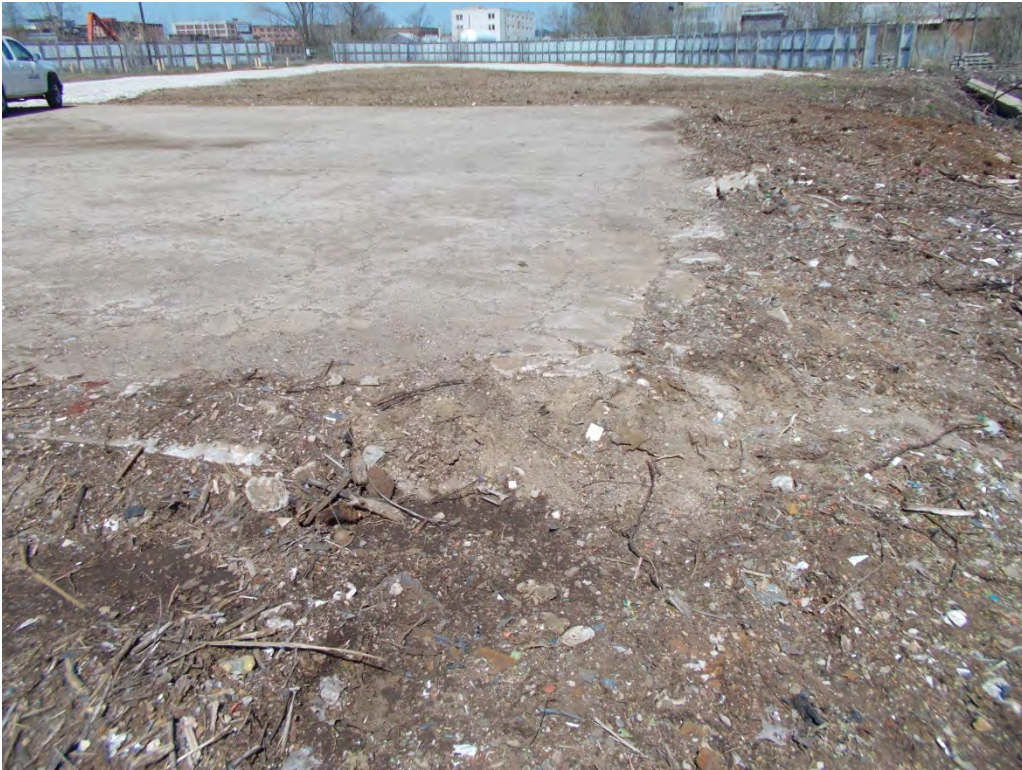
- The pavement is in critical to failed condition with alligator cracking and spalling throughout.

View of pavement looking north

- The pavement appears to be abandoned. Any further damage done during sediment removal operations does not likely need to be addressed.

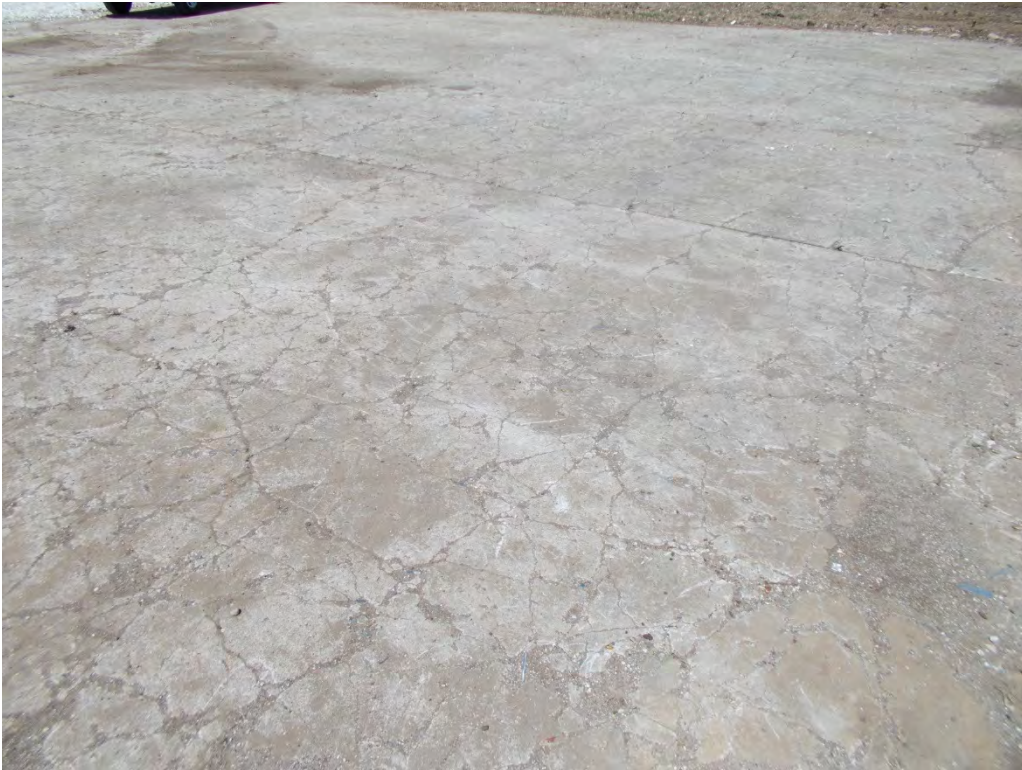
Severe cracking of pavement

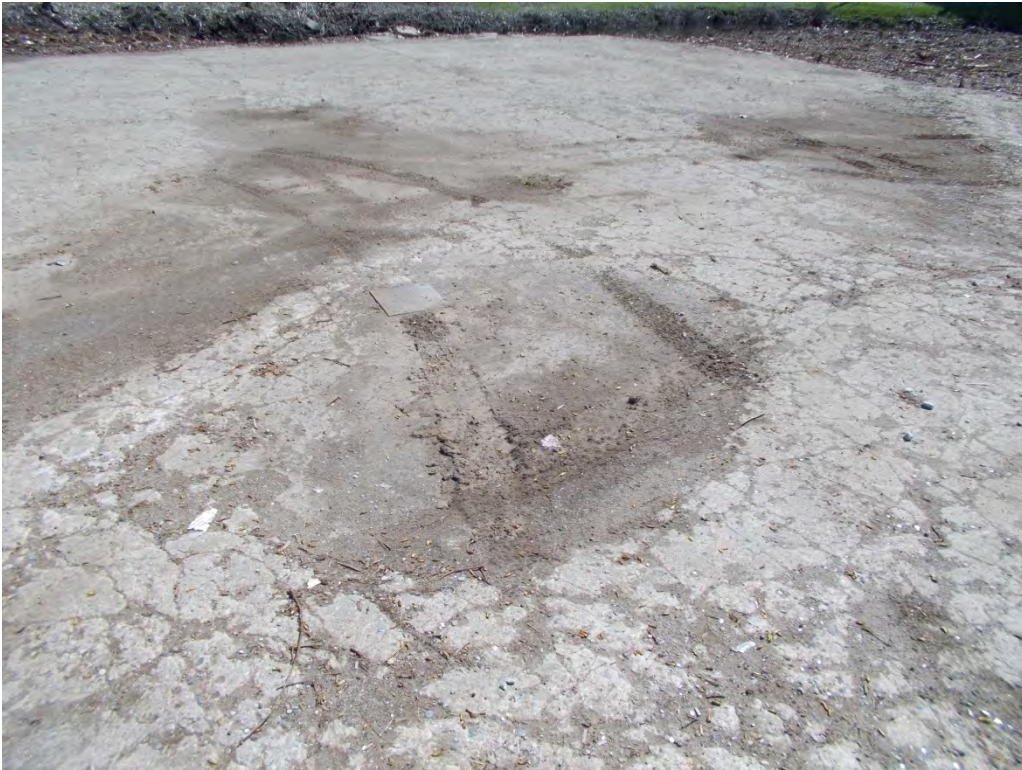
Patched area on interior area of pavement

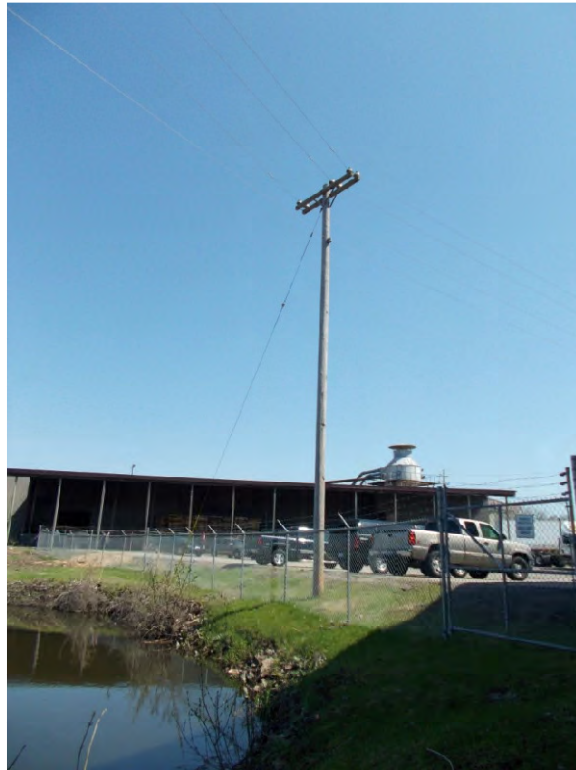
- The pole is weathered but otherwise appears to be in fair condition.

View of pole and guy looking northeast

- The pole appears to be beyond the influence of the sediment removal in the area. However, the guy is located near the water's edge. Sediment removal should be avoided within the 1:1 influence of the guy unless the pole is temporarily supported.
- Construction fencing or similar means should be used to identify the pole and guy to operators and drivers during the work.
- Due care should be used to avoid encroaching on the OSHA-mandated clearance for the overhead lines during sediment removal operations.

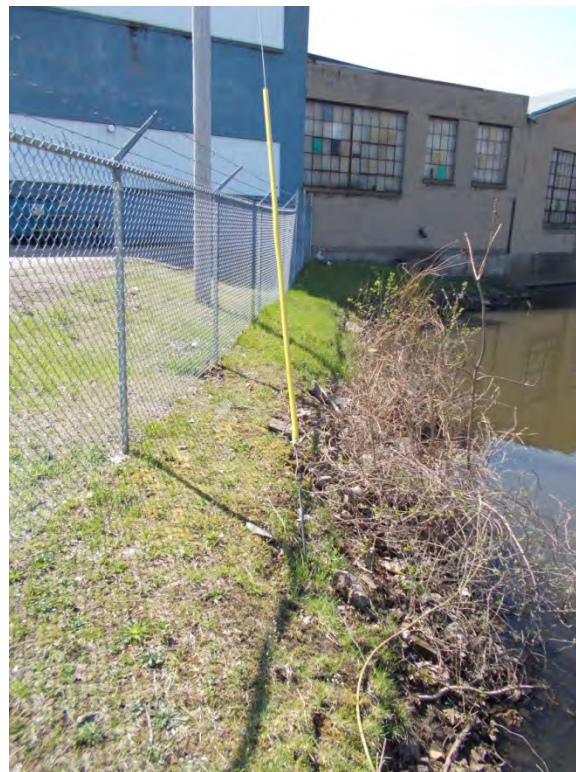
View of guy wire demonstrating proximity to the channel area

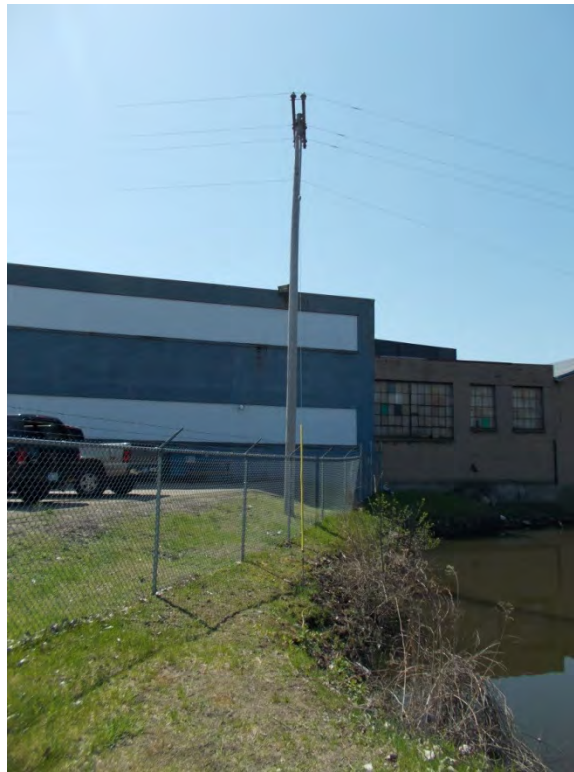
View of pole and guy looking south

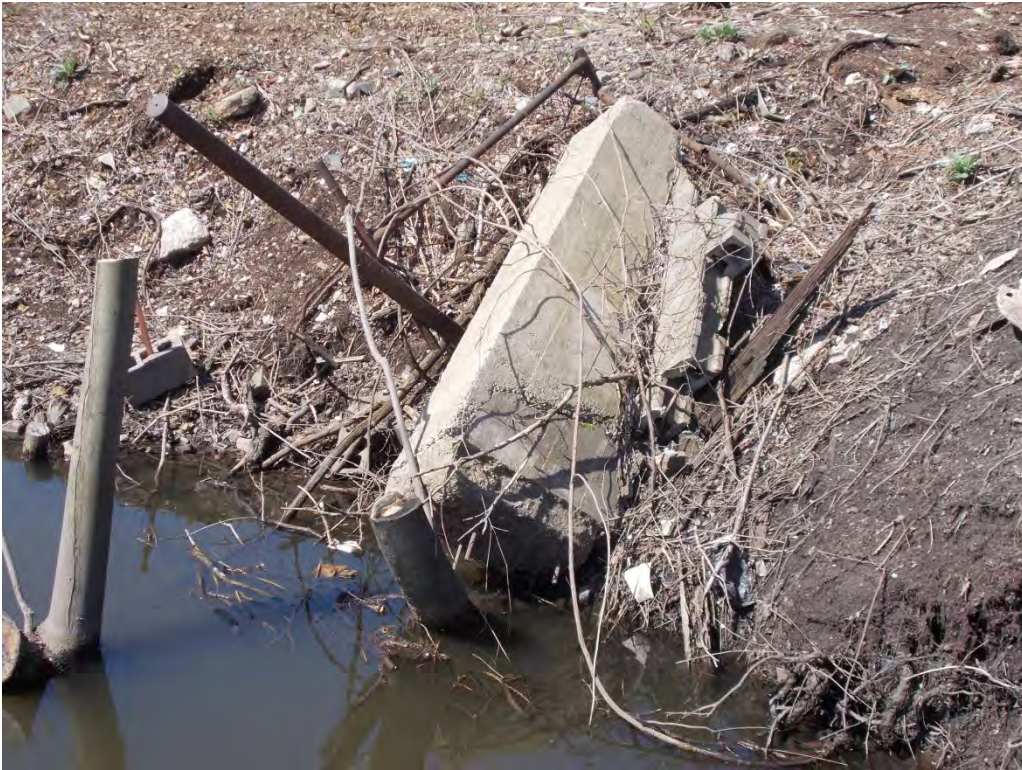
- The block and fence have failed and are falling into the channel area.

View of structure looking south

- It is likely that the block and fence can be removed in conjunction with sediment removal operations.

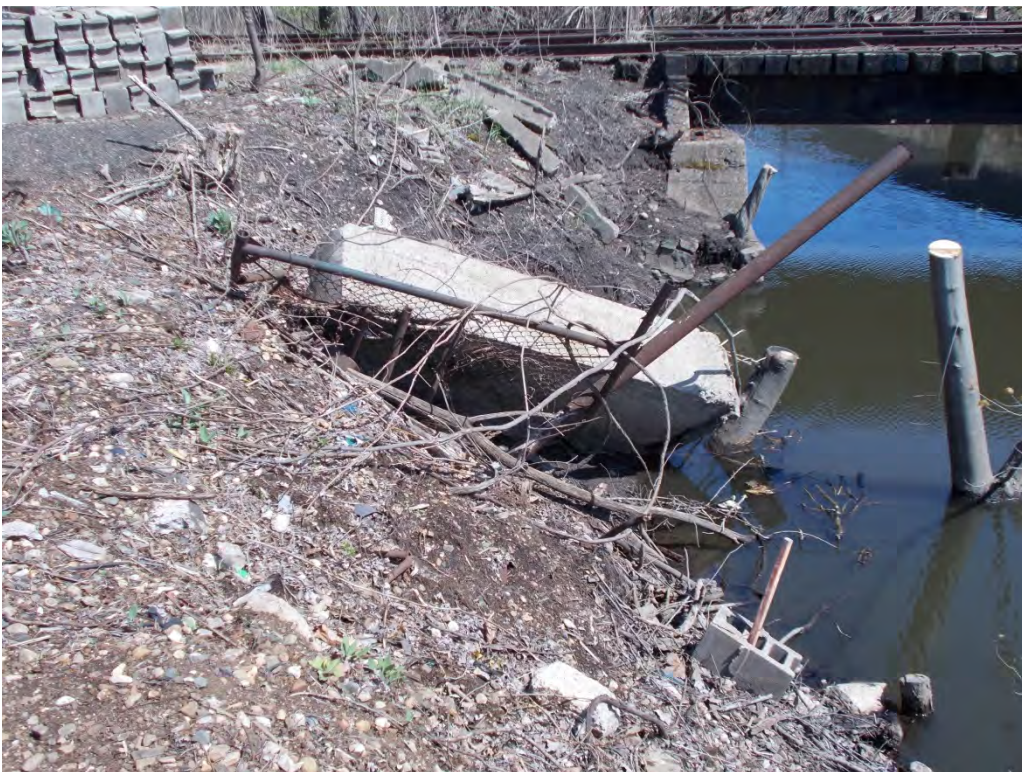
View of structure looking north

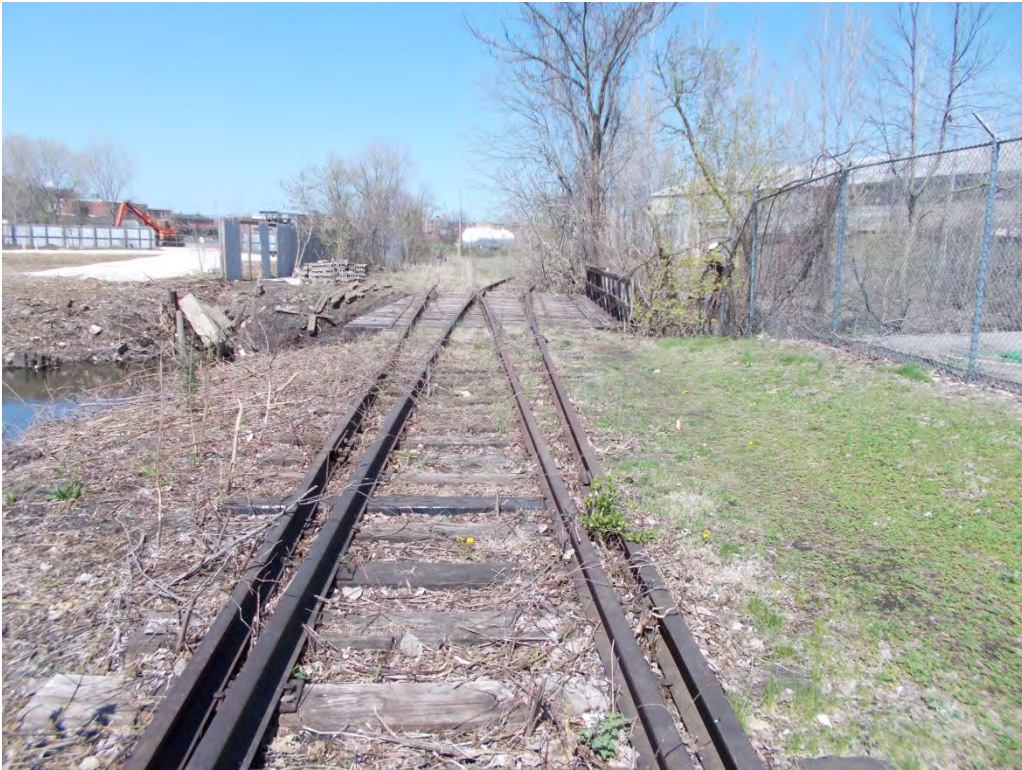
View of the structure from the southeast

- Due to the unknown foundation configuration, a minimum clearance of 5 feet is recommended for installation of the northern sheet pile wall. However, because the structure appears to be abandoned, settlement is not likely a significant concern if less clearance is required.

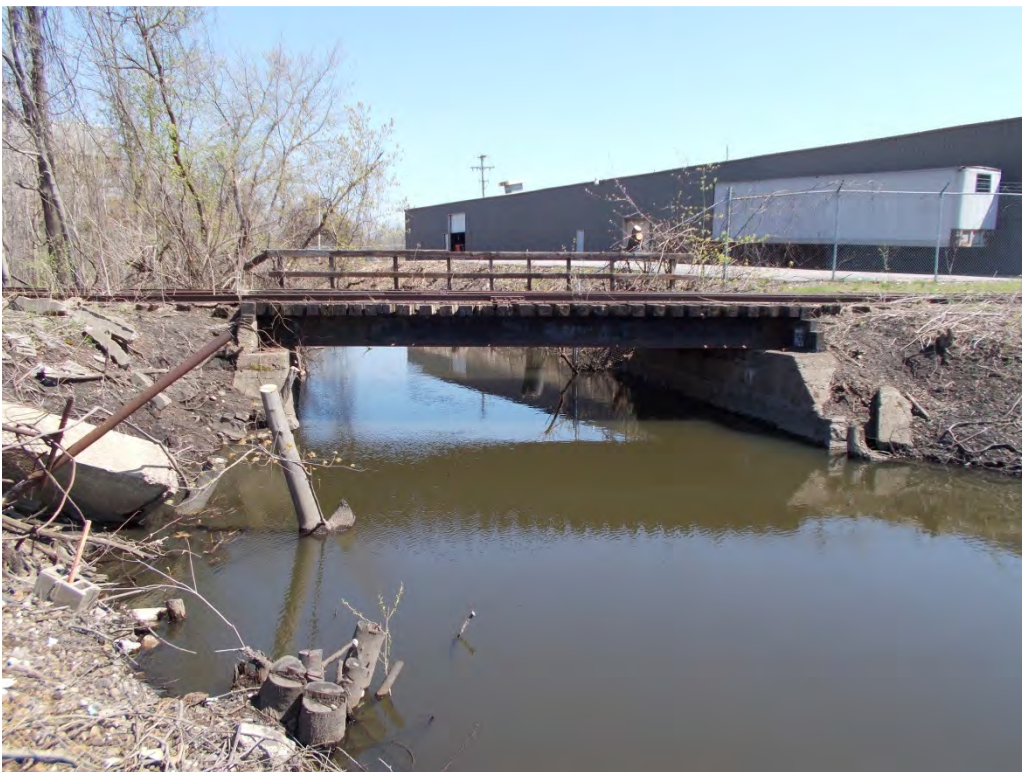
Elevation view looking northeast

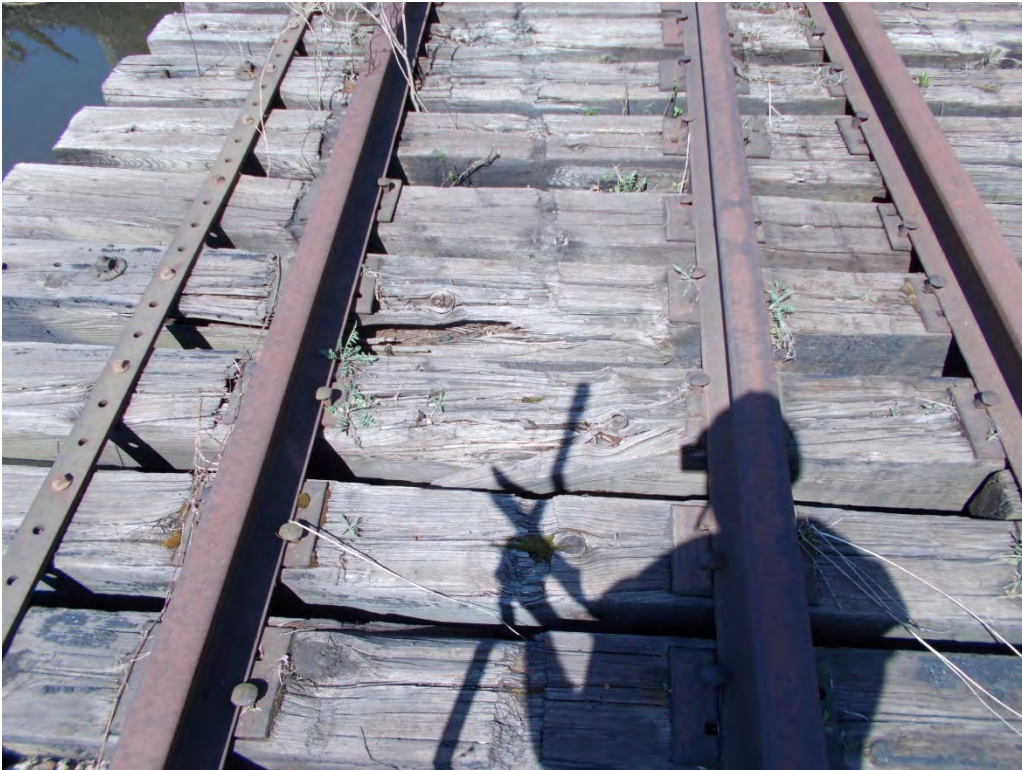
- The upper concrete abutments have moderate weathering. The lower stone abutments have grout voids, many of which have been patched. No undermining was detected.
- The steel beams have minor to moderate surface corrosion.
- Timber ties have severe to critical rot and section loss.
- The timber railing has a failed top plate the entire east half of the structure.
- The structure carries two sets of steel tracks, as it is located near a switch.
- Heavy brush is encroaching on the structure.
- Moderate to severe slope/bank erosion was noted all 4 quadrants. The channel spans abutment to abutment with no bank in place at the structure.

Severe section loss on timber ties

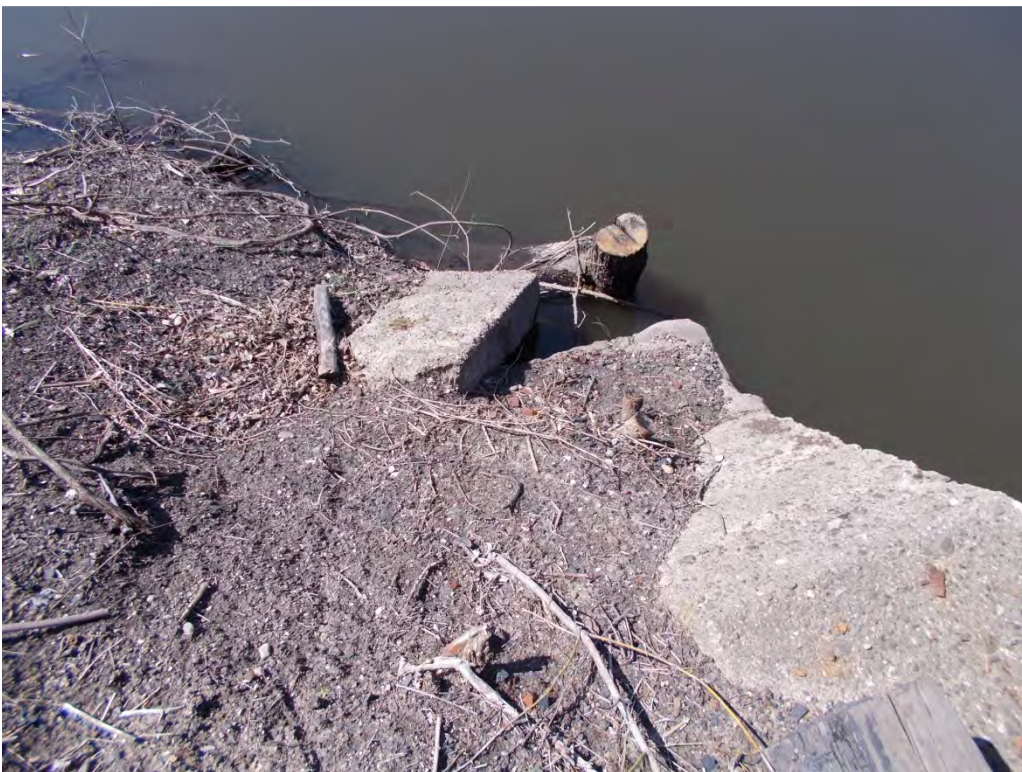
Bank erosion around corner of structure
